Windstorm Mitigation Report (OIR-B1-1802)

Raintree Village Condominium, Inc.
2101 Sunset Point Rd, Units 2201-2202
Clearwater, FL 33765

As of 02-13-2026 | FPAT File# MUD2625436

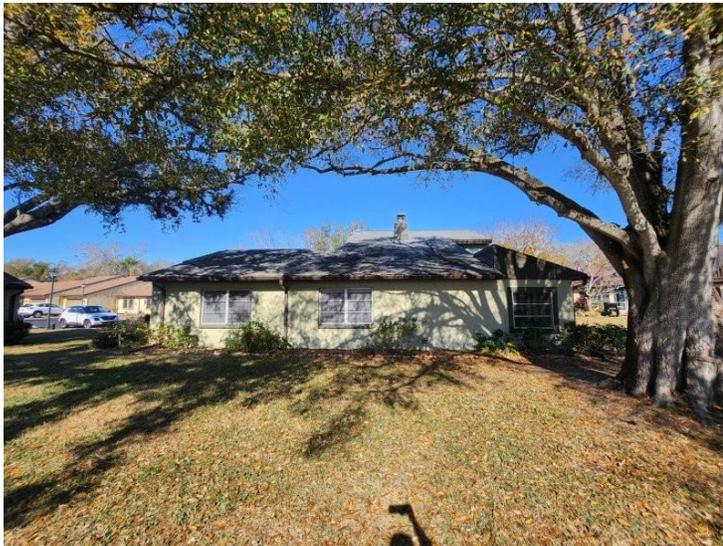
Exterior Elevation

- 4. Roof to Wall Attachment:** **Clips**
Comments: Inspection verified hurricane clips fastened with a minimum of three nails.
- 5. Roof Geometry:** **Other Roof**
Comments: Inspection verified a gable roof shape.

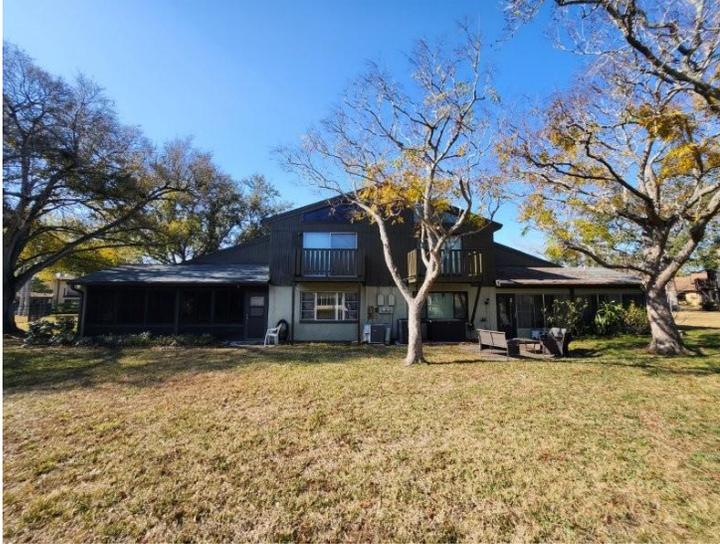
Roof Permit
Information

- 2. Roof Covering:** **FBC Equivalent**
Comments: The roof covering was replaced in 2020. The roof permit was confirmed and the permit number is BCP2020-070484. This roof was verified as meeting the building code requirements outlined on the mitigation affidavit.

Record BCP2020-070484:
Building - Construction Permit
Record Status: Completed

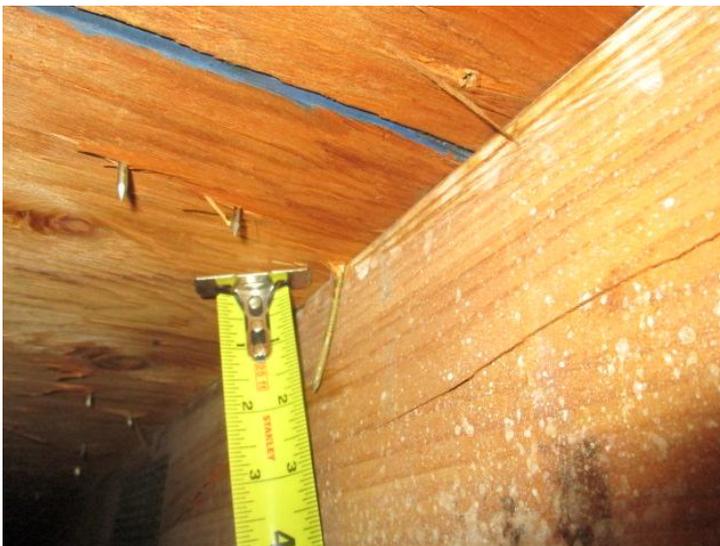
Roof Construction

- 3. Roof Deck Attachment:** **Level C**
Comments: Inspection verified 1/2" plywood roof deck attached with 8d nails at a minimum 6" on the edge & 6" in the field.

- 6. SWR:** **Yes**
Comments: SWR was verified at time of inspection. The Secondary Water Resistance verified is a self-adhering peel and stick.
- 7. Opening Protection:** **None or Some Glazed Openings**
Comments: Inspection verified some impact rated opening protection. Not all glazed openings were protected with impact resistant coverings.
