COMMERCIAL WINDSTORM MITIGATION REPORT (OIR-B1-1802)

Raintree Village Condominium

2101 Sunset Point Rd, Units 2601-2604
Clearwater, FL 33765

As of 7/1/2020
FPAT File# MUD2014600

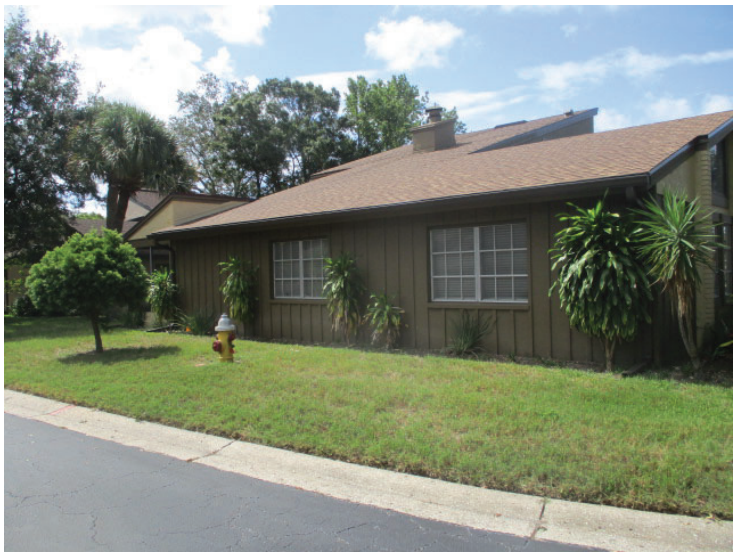
Exterior Elevation

4.	**Roof to Wall Attachment:**	**Clips**
	Comments:	Inspection verified hurricane clips fastened with a minimum of three nails.
5.	**Roof Geometry:**	**Other Roof**
	Comments:	Inspection verified a gable roof shape.

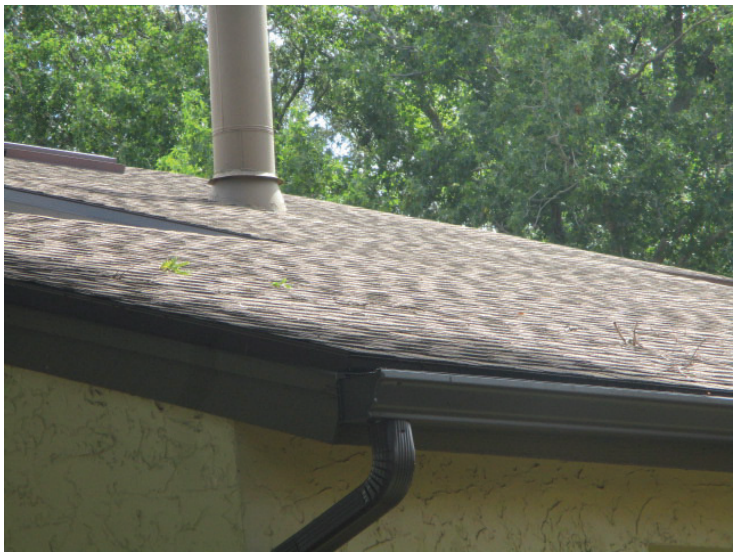
Roof Construction

3.	**Roof Deck Attachment:**	**Level C**
	Comments:	Inspection verified 1/2" plywood roof deck attached with 8d nails at a minimum 6" on the edge & 6" in the field.
